Manhole Inspection Summary

Manhole # S45MM_027MH

Insp Date: **3/24/08 12:48 PM**

Location Address: **North Alley Lafayette**

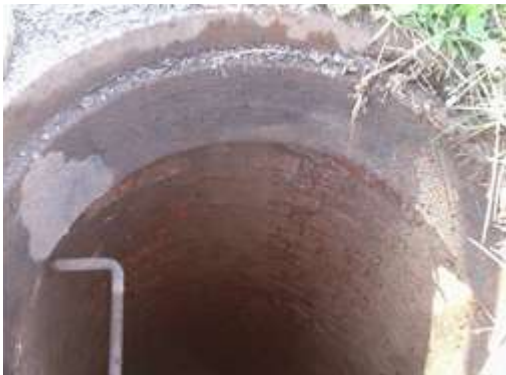
Defect 1

Infiltration: ☐ None ☐ Joint ☐ Cracks ☒ **Mortar** ☐ Roots ☒ **Wall**

Adjustment Joint

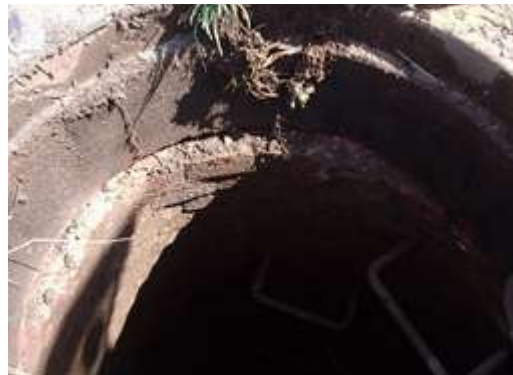
Defect 2

Frame Offset: **2** (in.) Condition: ☐ Sound ☐ Cracked ☒ **Leaks**

Frame Leaks

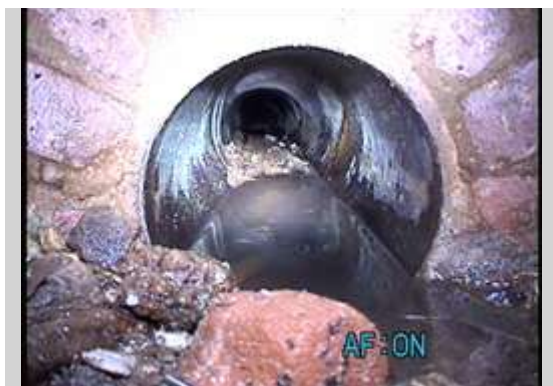
12 O'Clock Outflow

8 in. Circular Gravity Sewer
Pipe Out @ 12 O'Clock

Deposits: ☐ None ☒ **Mud** ☒ **Gravy** ☒ **Debris** ☐ Grease

Silt Depth: **3** (in.) Deposits Extent: **Medium**
